11 Chris Bang Crescent, Vaucluse NSW 2030

OBJECTION to Section 4.55 - Application for Modification of Development Consent
Application DA-206/2016/B

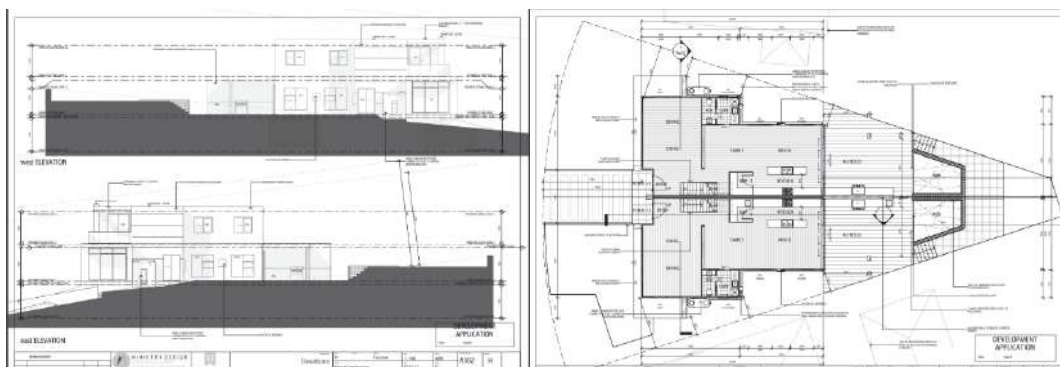
DA-206/2016 approved only an alfresco area, with a Colourbond roof over the ground floor (see below approved DA-206/2016 plans). On page 14 of the ASSE, when referring to Elevated decks and balconies, reference is made to a Colourbond roof. Does this mean that the owners will be replacing the existing concrete roof with a Colourbond roof?

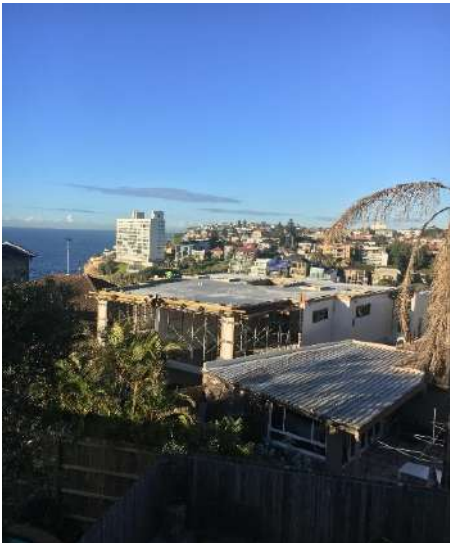
If the owners are seeking to keep this structure, then an objection is raised as there is no justification for these unapproved covered balconies to exceed the Waverly DCP (2012). The image at right clearly shows how this unauthorised structure adds to the considerable, concrete, visual bulk of the property.

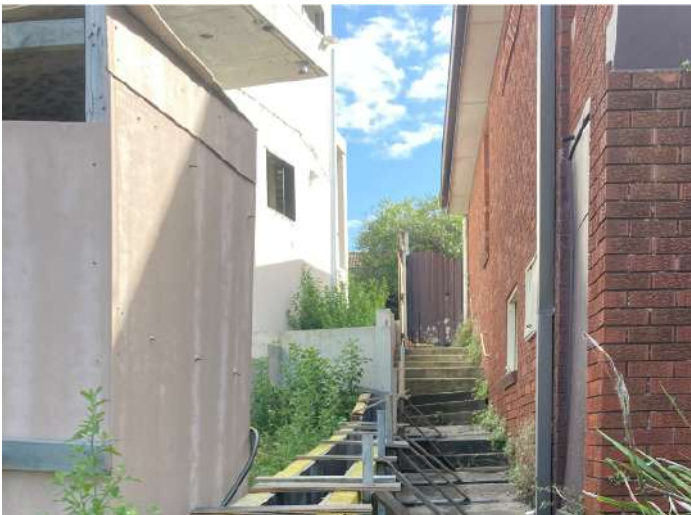
Not only is the AAP seeking approval for the unapproved side setback breaches, the photographs below, show that what has been built breaches even the side setbacks documented in the AAP’s. There is nothing in the documentation to suggest that the walls will be taken down and rebuilt to fall within the approved setbacks.

Page 13 of the ASEE it refers to “the extremely minor exception of the balcony edge”. However, one can see from the photograph on the left that the side setback breach on the Eastern balcony is significantly less than 1.428m. In fact, it is almost on the boundary

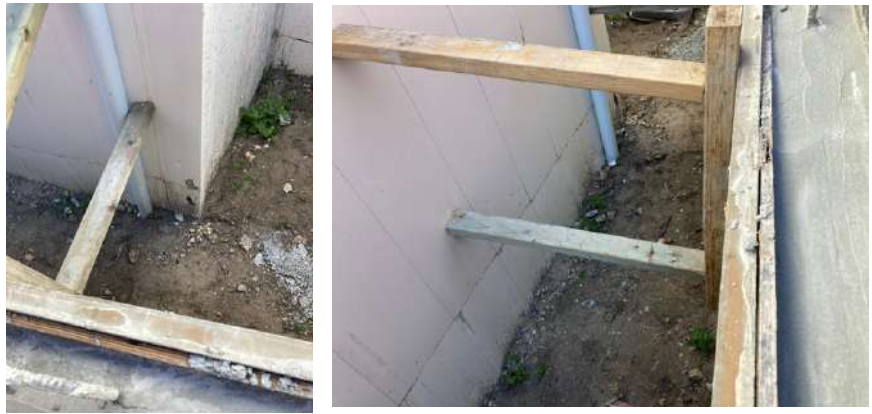
The ASEE is justifying the side setback breaches, by saying the variations are more significant on the basement level, which is below ground, therefore insignificant. However, the photographs on the Eastern boundary show the extent of the side setback breaches on the ground level.

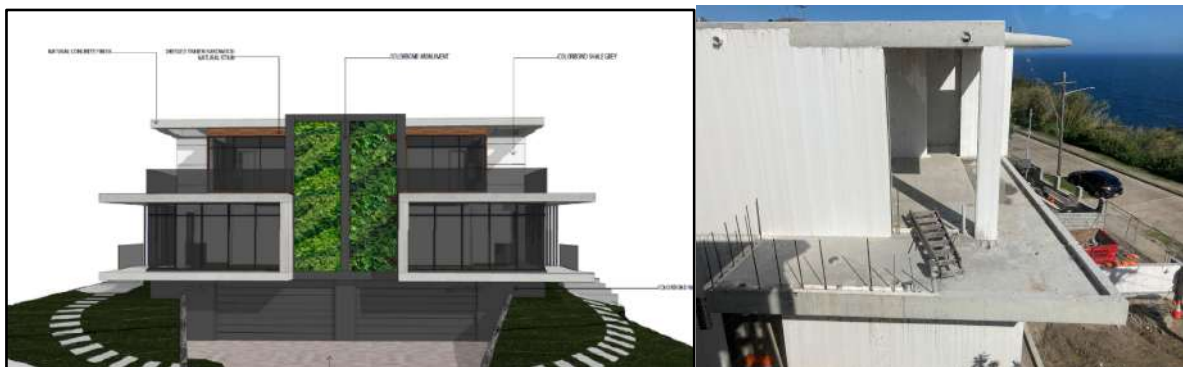
The amended plans do not address the unapproved work done in bedroom 1. Below is a photomontage of the development that was approved in DA-206/2016. There is also a photograph of the balcony taken from #12 Chris Bang Crescent which shows that bedroom 1 has been extended to enclose the balcony, resulting in a larger space, once again breaching the FSR. The owners have extended the concrete wall out to where a glass balustrade is shown in the photomontage. The owners are also looking to add additional screening and bulk to the edge of the balcony which was not approved in DA-206/2016.

The amended plans do not show any remedy of the breach, but rather seek retrospective approval by passing it off as “added column and wall for structural support to concrete roof”. Shown as #3 on first floor amended plans. No reference to these changes are made in the ASEE.

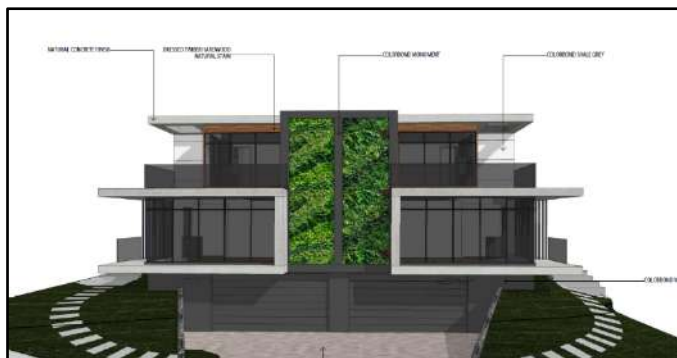
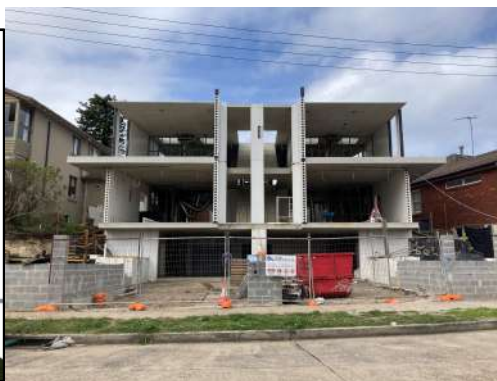
The first application submitted for DA-206/2016 provided for two 5m wide driveways. However, this was not approved by council and in order to obtain approval the plans were modified to allow for a common driveway access from the street that would be a maximum of 4.9m wide. It appears that council rejected the first proposal due to two driveways resulting in the reduction of on-street car parking in Chris Bang Crescent. There was also a reference that the shared driveways were located approximately 1.69m east of the nearest stormwater pit.

Below is a photomontage submitted with the amended plans showing the shared driveway and a picture of the current development showing two driveways greater than the width of the garage.

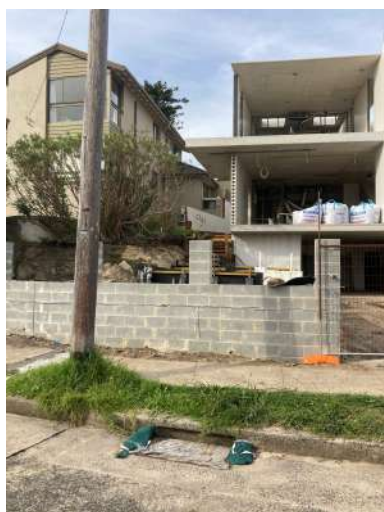
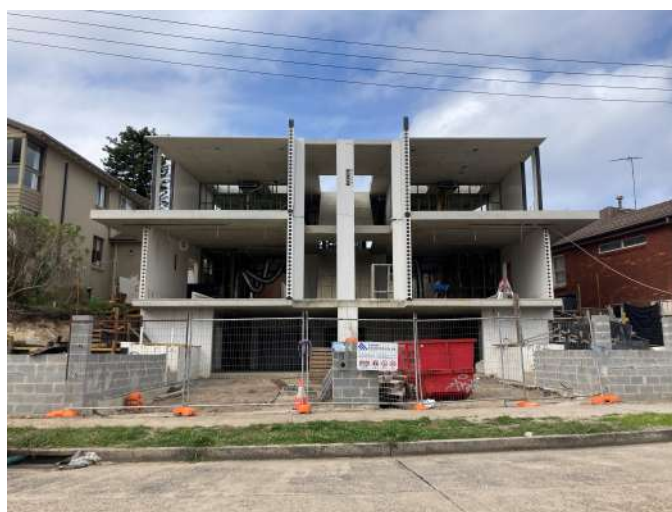
The original architectural plans showed no fences to the proposed street boundary and this was re-clarified in the amended plans, that were subsequently approved by council. Below please find a picture that shows the front walls that have been erected in the street boundary and on council land. No permission was given by council to enclose part of council land.

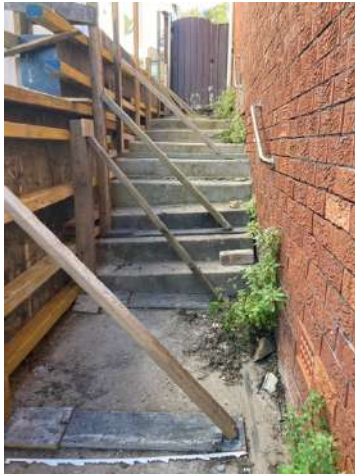
Excavation was done right up to the boundary walls on the eastern, western and northern boundaries, which resulted in the fences on the eastern and western boundaries collapsing, the stairs to the neighbouring property #10 Chris Bang Crescent being destroyed and damage to the gardens of #10 and #12 Chris Bang Crescent. There is subsidence in the garden of #10.

The owners of #11 Chris Bang Crescent did a rudimentary job of fixing the stairs at #10 Chris Bang Crescent, but the repair work was badly done, resulting in uneven step. As a result, the 92-year-old owner and her guests are unable to use these stairs. This may not seem like a major issue, but these are the stairs that a lot of Mrs Silver's elderly guests used to access her home, as the front stairs are quite steep. Although having visitors whilst we are in lockdown may not seem relevant, it is very important to Mrs Silver, as many of her friends will be unable to visit her once lockdown is lifted.
